Report/Article Title Decontamination of the Binghamton State Office Building, Progress Report - May 1983

DECONTAMINATION OF THE BINGHAMTON STATE OFFICE BUILDING

Progress Report - May 1983

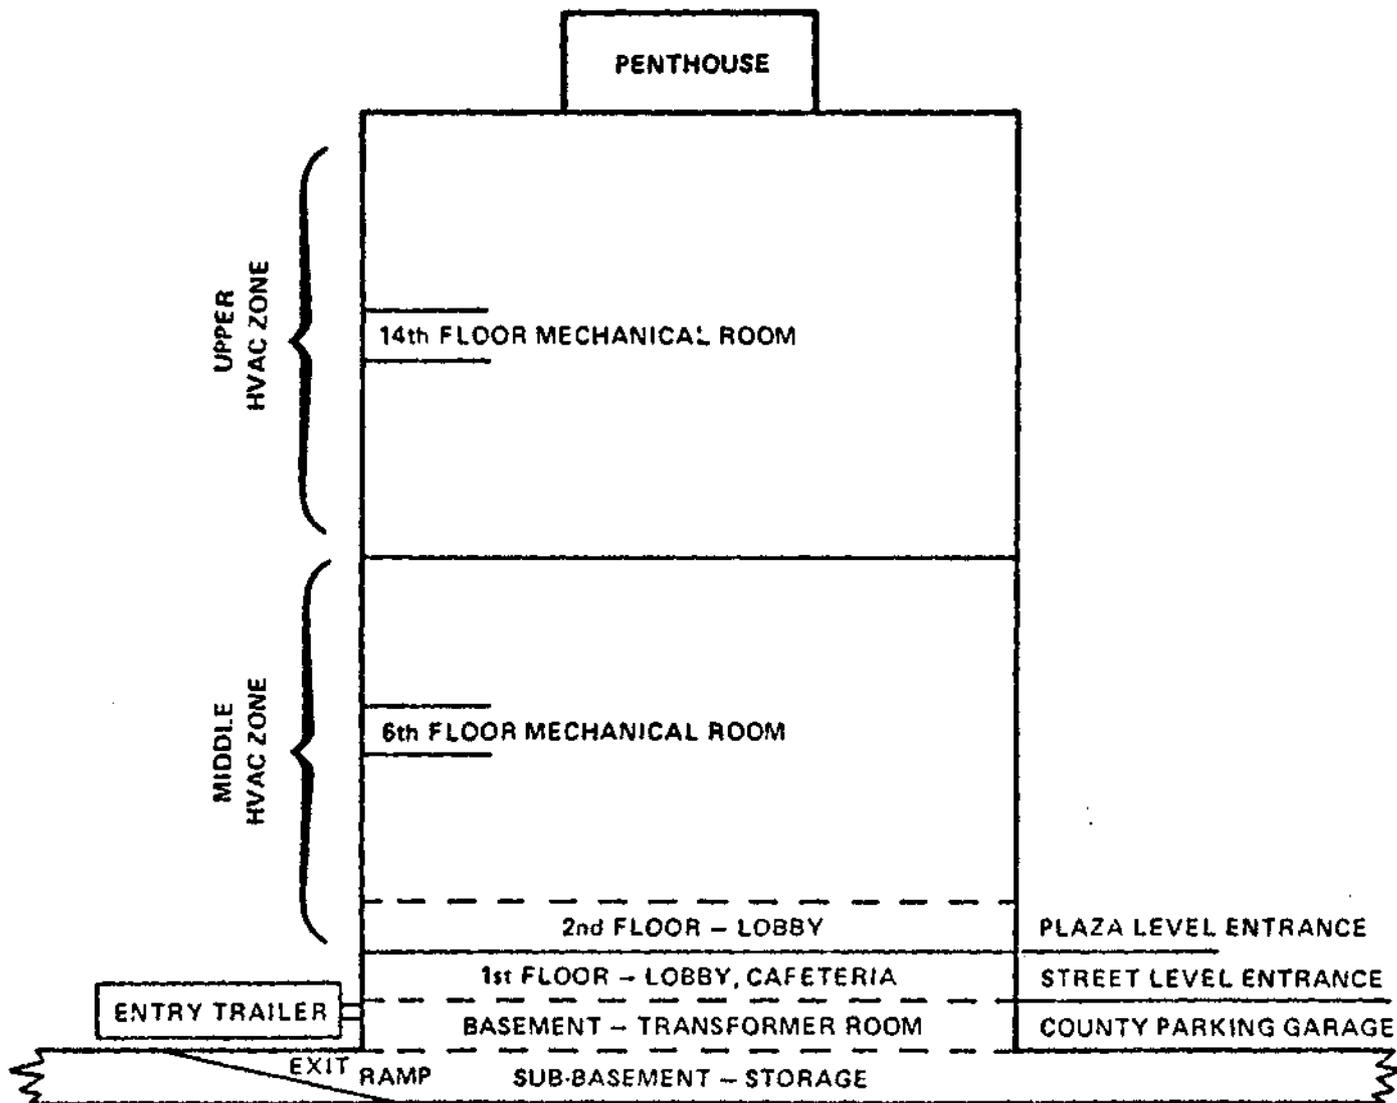
FIGURE 1. BINGHAMTON STATE OFFICE BUILDING

The Binghamton State Office Building is a 260-foot tall tower within the government complex in Binghamton, New York. The building consists of 17 office floors, a penthouse for elevator equipment, and basement and sub-basement levels (see Figure 1). The heating and ventilation is broken into three zones: sub-basement through first floor; floors two through ten; and floors eleven through penthouse.
