Purpose. This Environmental Baseline Survey (EBS) documents the physical condition of Air Force real property at Loring Air Force Base (AFB), Maine, resulting from the storage, use, and disposal of hazardous substances and petroleum products throughout the base's history. The EBS collects into a single document all available information to establish a baseline for use by the Air Force in making decisions concerning real property transactions.

Loring AFB, scheduled to close in September 1994, consists of 8,702 on-site acres and 780 off-site acres. The off-site property is made up of the

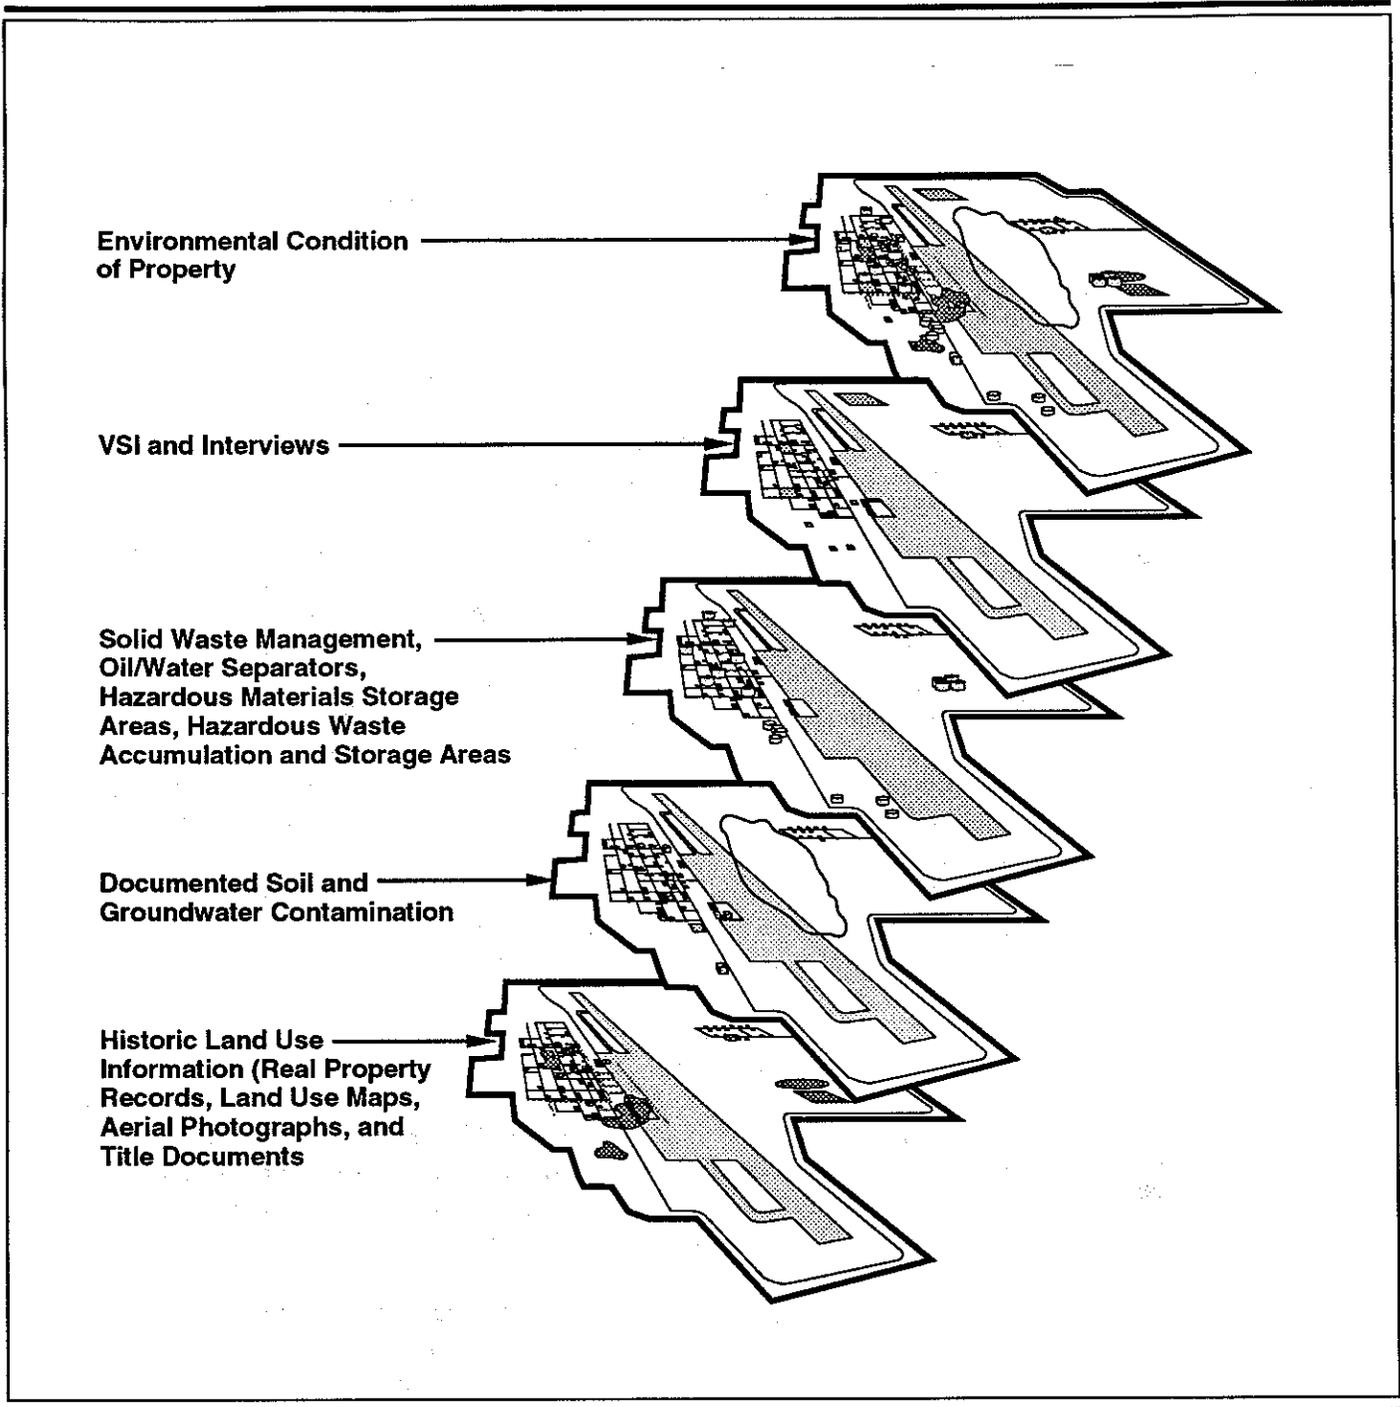
Figure 2-1

The result is a collection of all available information into "layers" that, when laid over each other, provide a complete picture of the property's condition. This enables the researchers to categorize the property into defined environmental condition categories and identify data gaps (Figure 2-1).

Resource Layer Approach

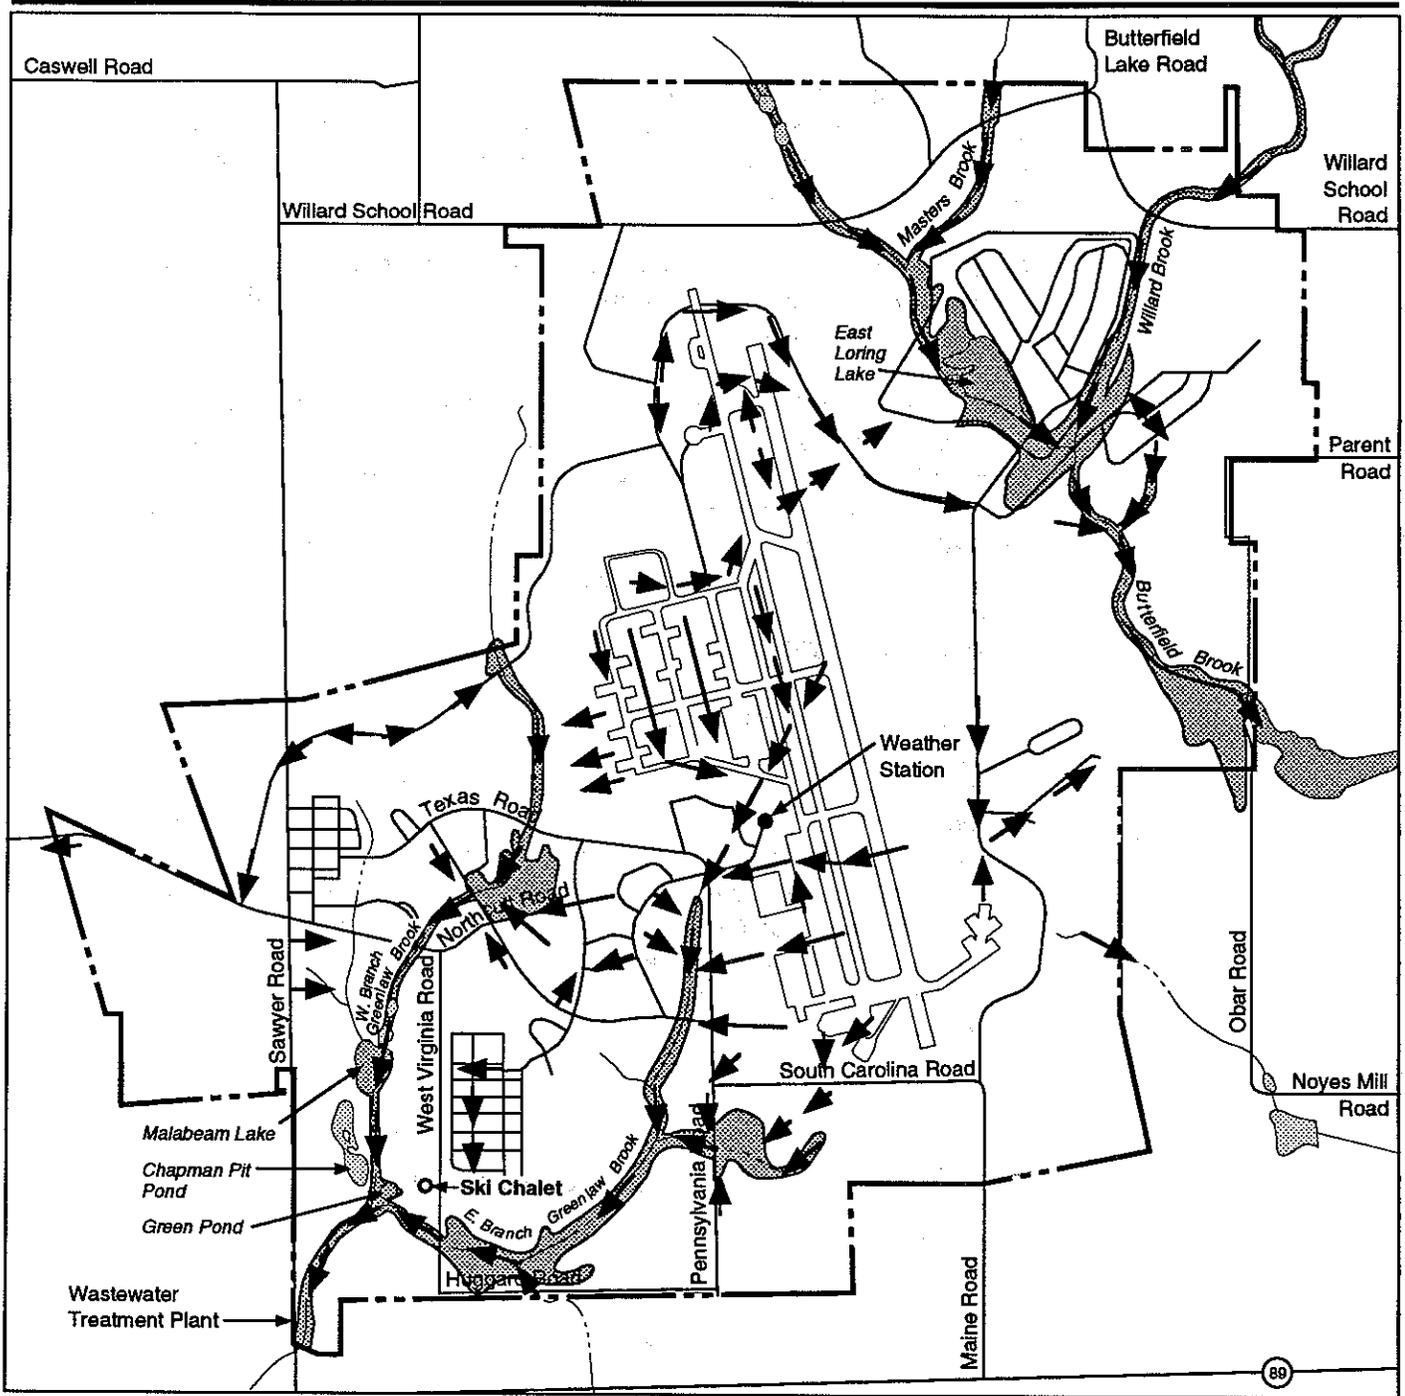
Main Base. The Aroostook River eventually receives flow from all of the properties at Loring AFB (Figure 3-6). The main base is situated on a gently sloping plateau on a drainage divide between tributaries of the Aroostook River. The runway is located approximately at the crest of the divide. Drainage from the runway and areas west of the runway is collected by Greenlaw Brook. In addition to receiving flow from several ditches and culverts draining the western portion of the base, Greenlaw Brook has two primary tributaries, which merge in the southwest portion of the base. The East Branch of Greenlaw Brook collects most of the runoff from the flightline and the runway. The West Branch of Greenlaw Brook drains parts of the housing and cantonment areas. Greenlaw Brook also receives discharge from the WWTP located in the southwest corner of the base. Greenlaw Brook exits the base, flowing southwest, and discharges into the Little Madawaska River, which eventually flows south into the Aroostook River.
