A history of buoys and tenders

by Amy K. Marshall

A history of buoys and tenders is a Commandant's Bulletin insert for November 1995. For information about the Coast Guard, visit your local library or write to the Coast Guard Historian's office at: Commandant (G-CP-4), 2100 2nd St., S.W., Washington, DC 20593-0001. Editing, design and layout by CWO3 Paul A. Powers. Photos courtesy of the Coast Guard Historian's office.

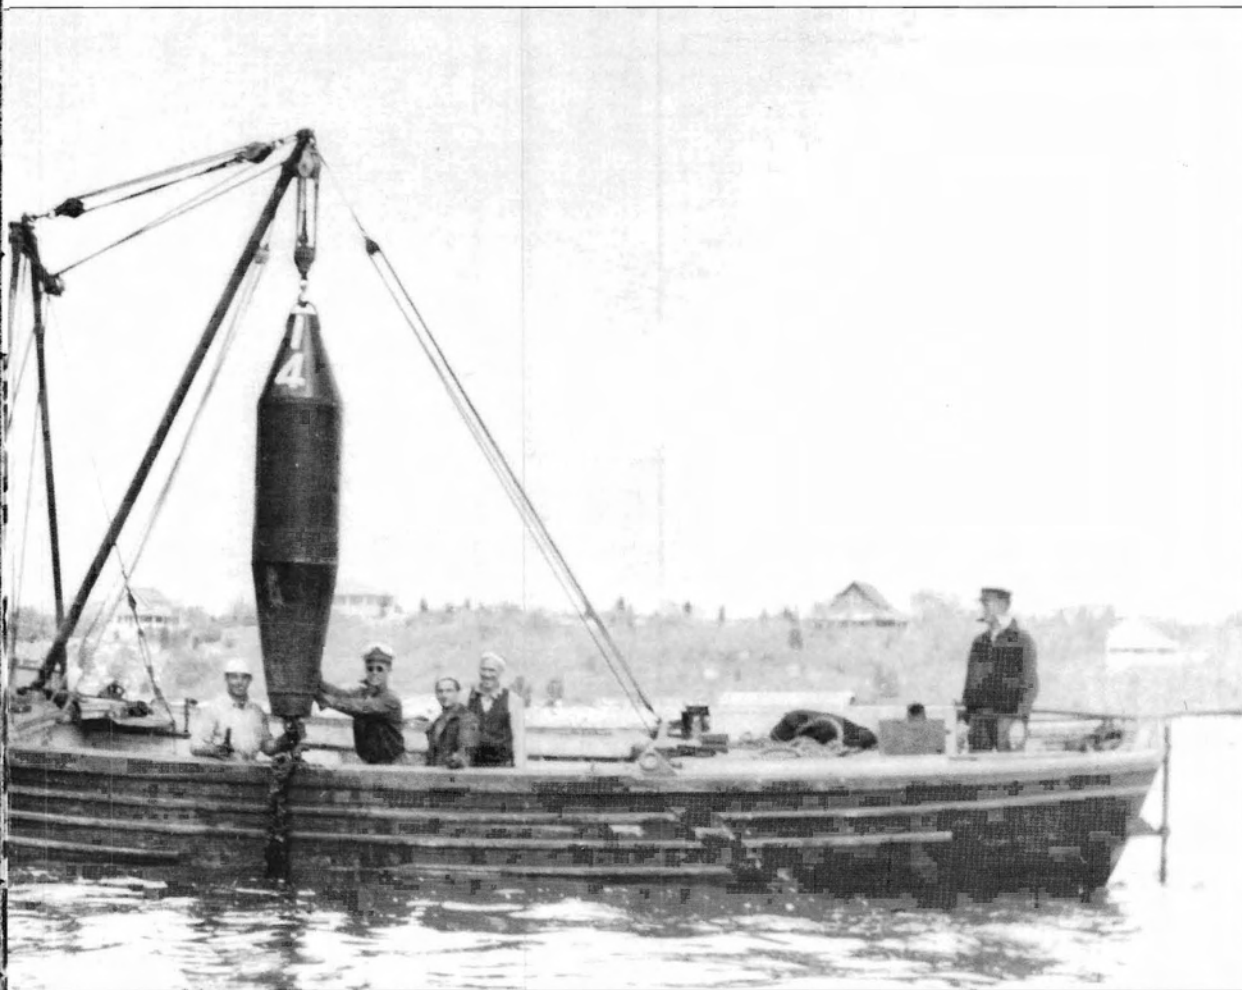
Smallboats were used in the 19th century to tend buoys. They did not become obsolete when navigational aids increased in size and complexity. This boat and crew are working a second class nun buoy in the Square River of Massachusetts in the 1930s.

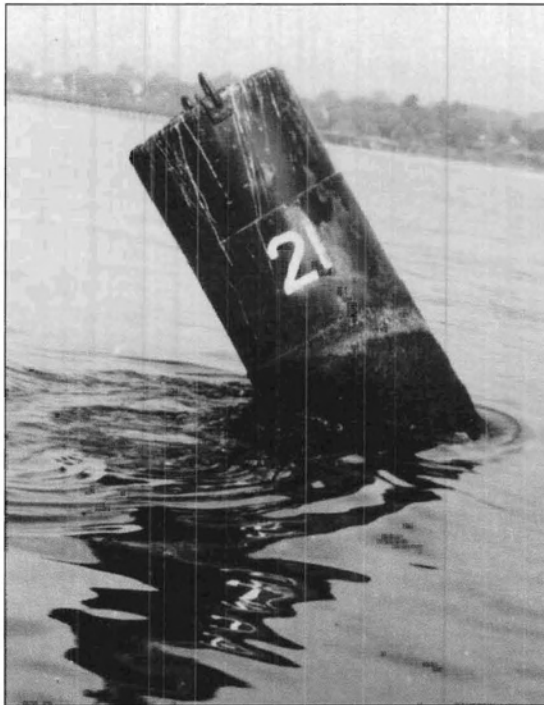
Among the most recognizable buoys, this second-order black can buoy (right) fights a swift current. Pulled in by their mooring chains and suspended upside down to check for marine growth, a first class riveted iron can (far right, top) and a first class nun (far right, bottom) are brought aboard tenders. Buoys and tender crews constantly battle marine growth and attacks by borers. In the 19th century, the Lighthouse Board actively encouraged development of anti-fouling paints for both wooden and iron buoys.

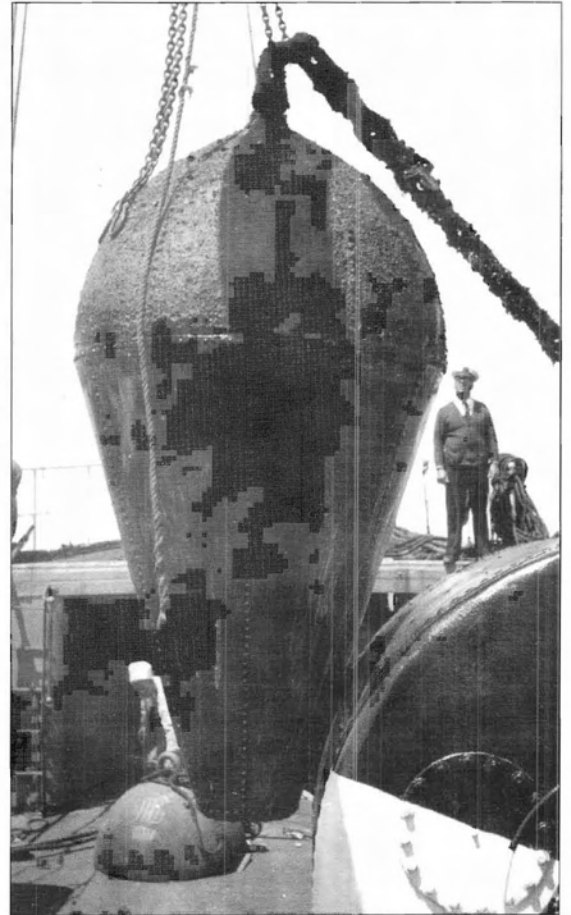
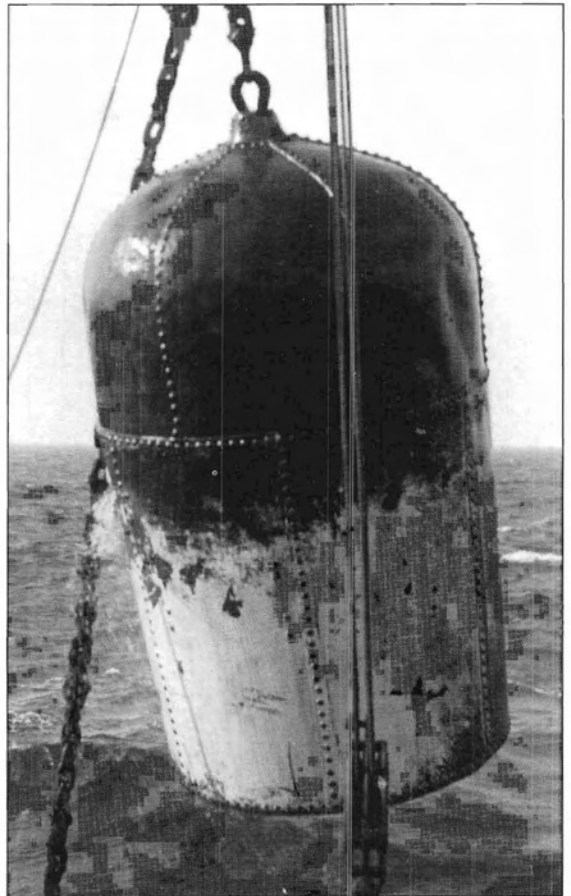
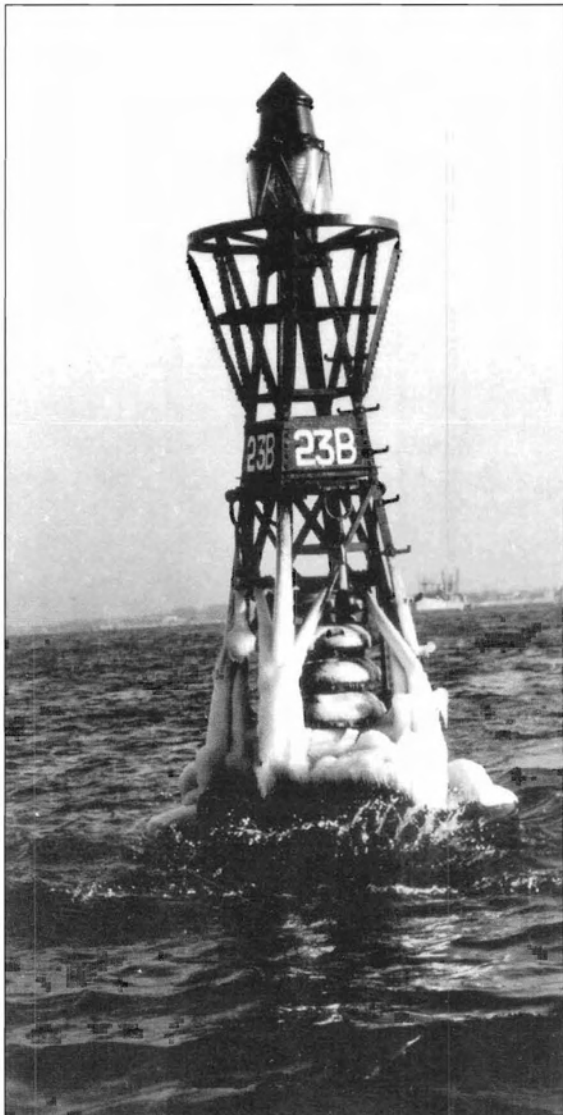
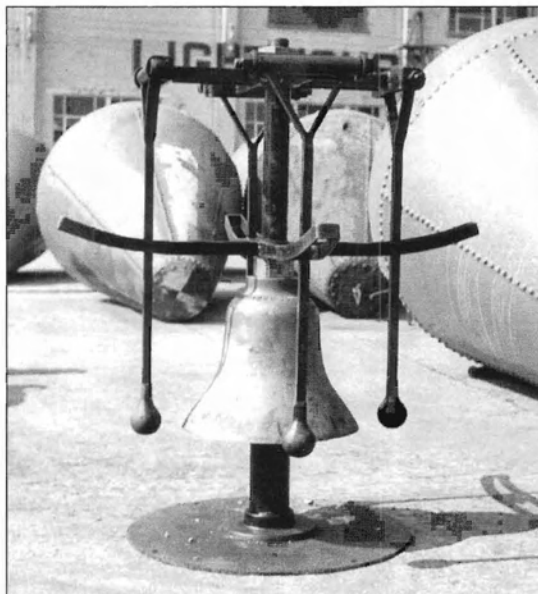
The Lighthouse Service continued to push for technological advances that would make America's seafarers the safest in the world. (Clockwise from upper left) The lighted gong buoy, with its distinctive three-note chime, was declared a success after extensive tests in 1922.

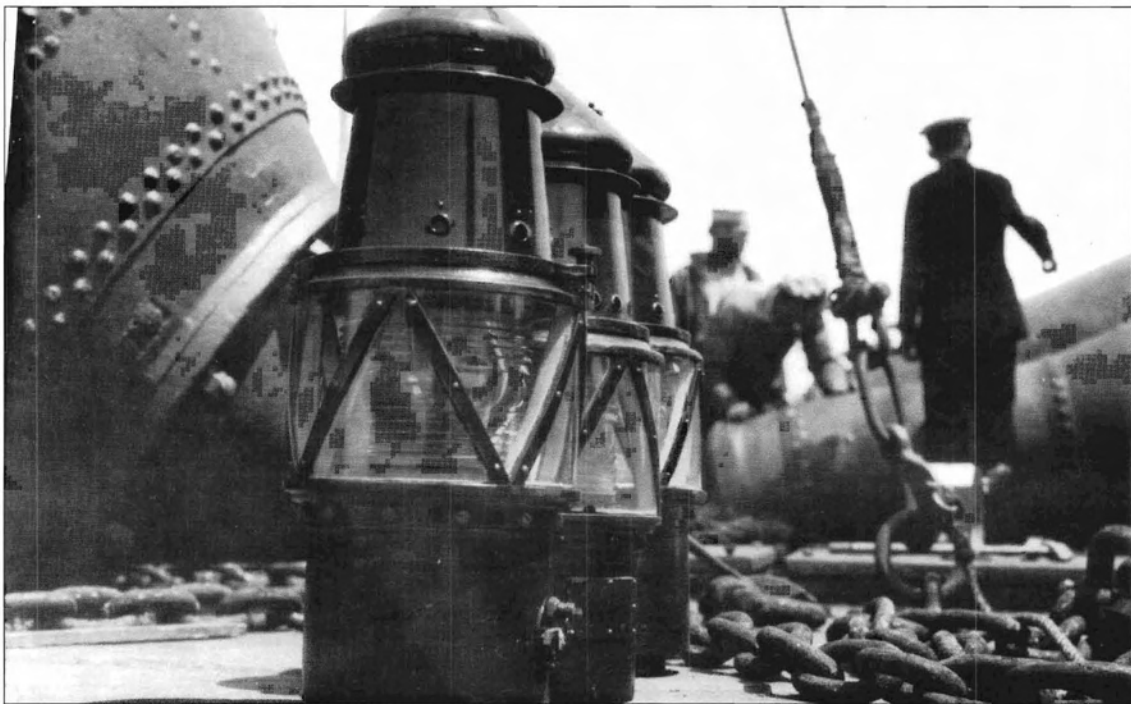
The clapper assembly from a bell buoy clearly demonstrates how the bell would be struck as the buoy rolled in the sea. Buoy lanterns, equipped with Fresnel lenses, stand ready for installation.

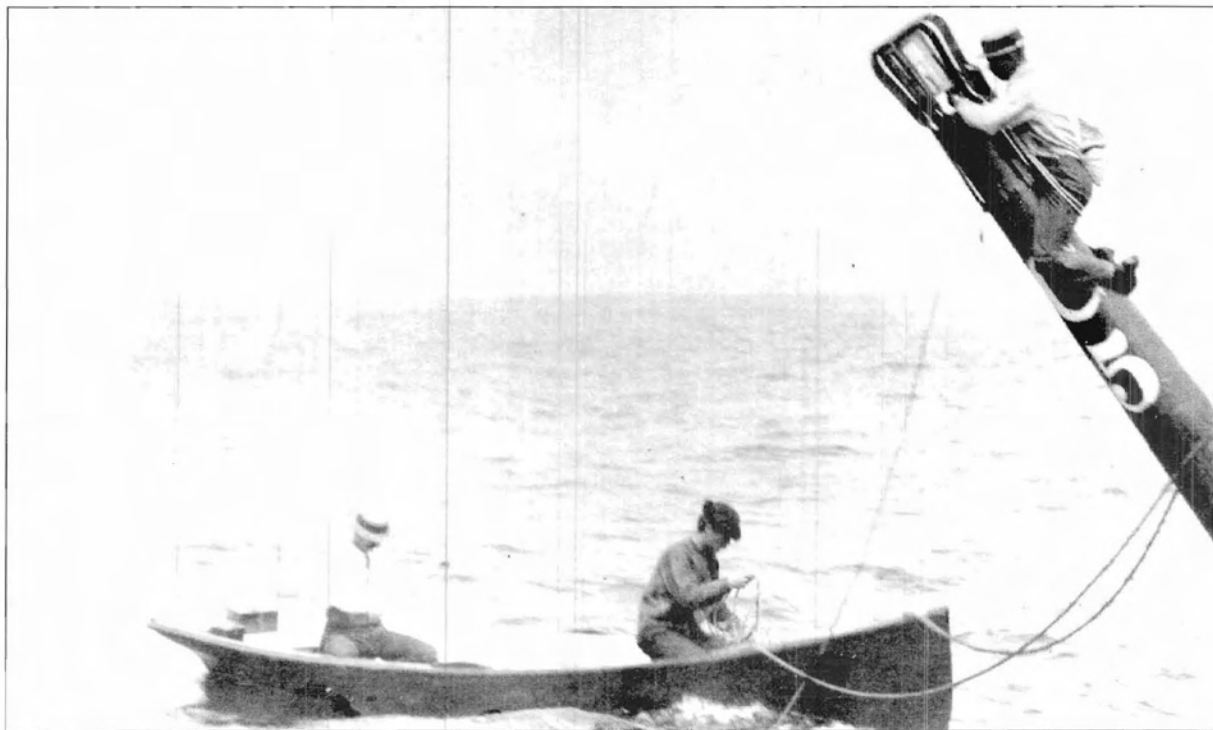
Experiments with electric light. A tender crewman straddles a lighted spar buoy in Gedney's Channel, New York harbor. The buoy, one of a series of five, was connected by a cable to a generator on Sandy Hook, N.J. These buoys demonstrated that electric spars were unfeasible. Problems included the screws of deep-draft ships severing the power cable.

ployed in Gedney's Channel, New York harbor, in 1888, a series of these buoys was lit by a cable running to a generator on Sandy Hook, N.J. These were removed in 1903.

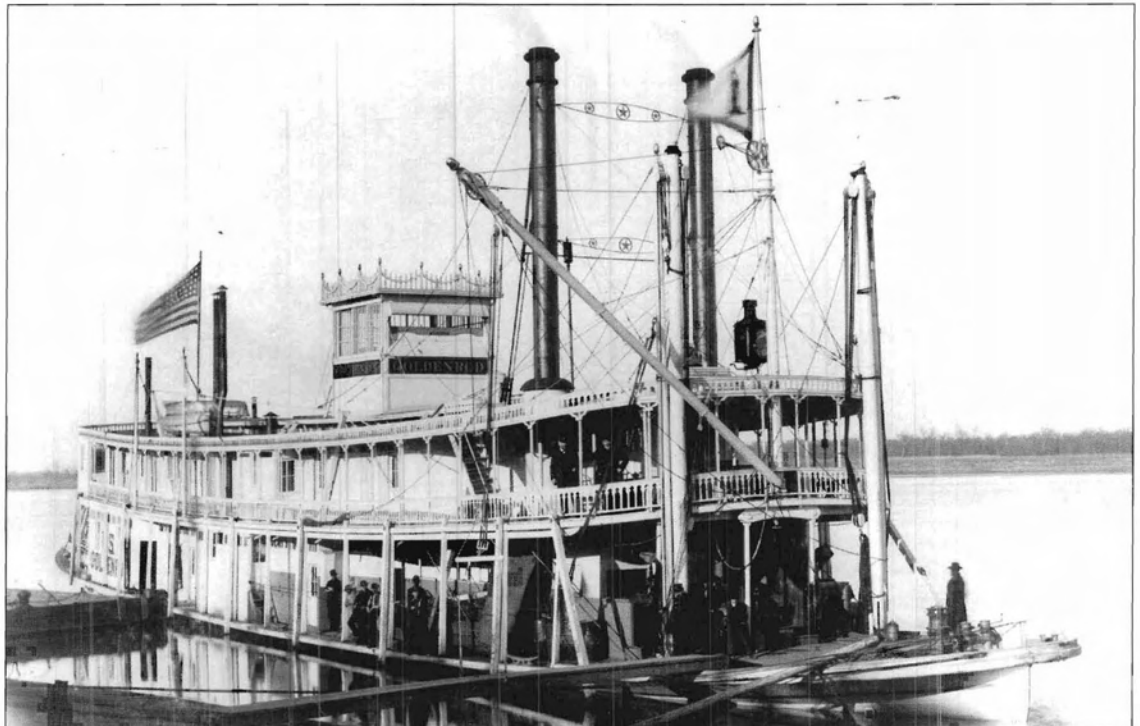
Lighthouse Service "showboat," the Goldenrod, a steam-powered, stern-paddle wheeler, served as a tender on the Mississippi River.

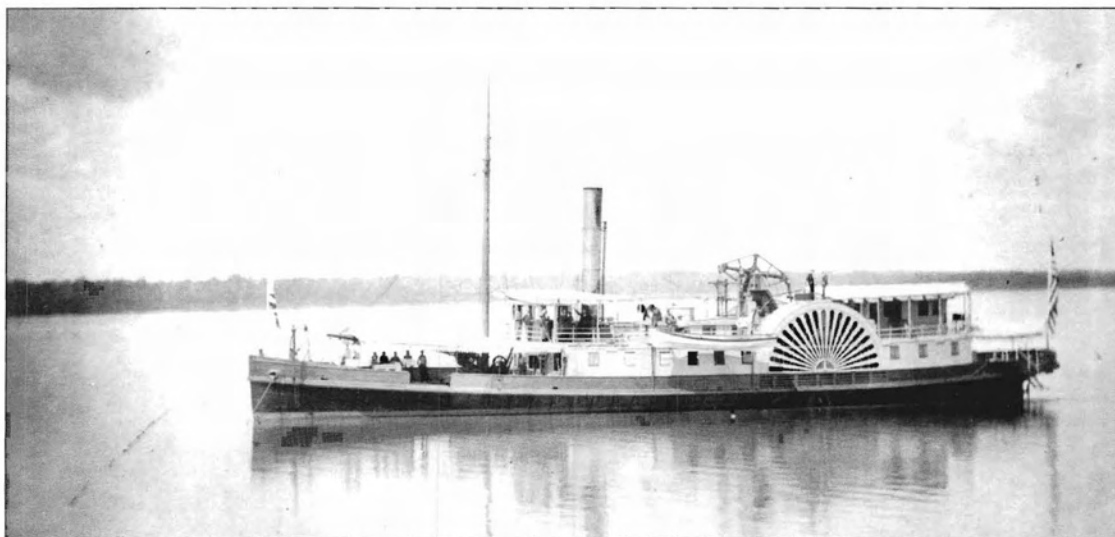
The USLHS Jessamine as it appeared in 1885. A side-wheel steamer with a walking beam engine, the Jessamine served primarily as a supply vessel for lighthouses. It was not, however, above doing the tough job of tending buoys.

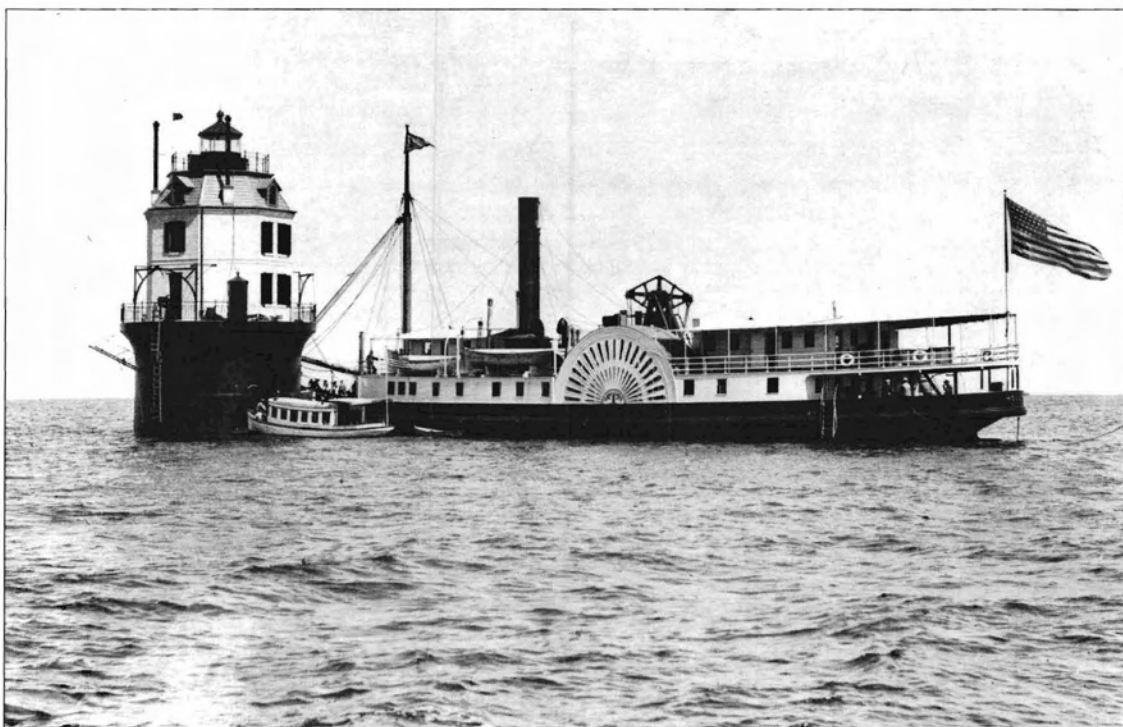
The USLHS Holly and a small steam launch at a lighthouse. Along with buoy-tending duties, early tenders like the Holly were required to supply remote lighthouses and conduct inspections on their quarterly district tours. Here the Holly, a side-wheel steamer with a walking beam like the Jessamine, is re-supplying a lighthouse and conducting a tour of the district.

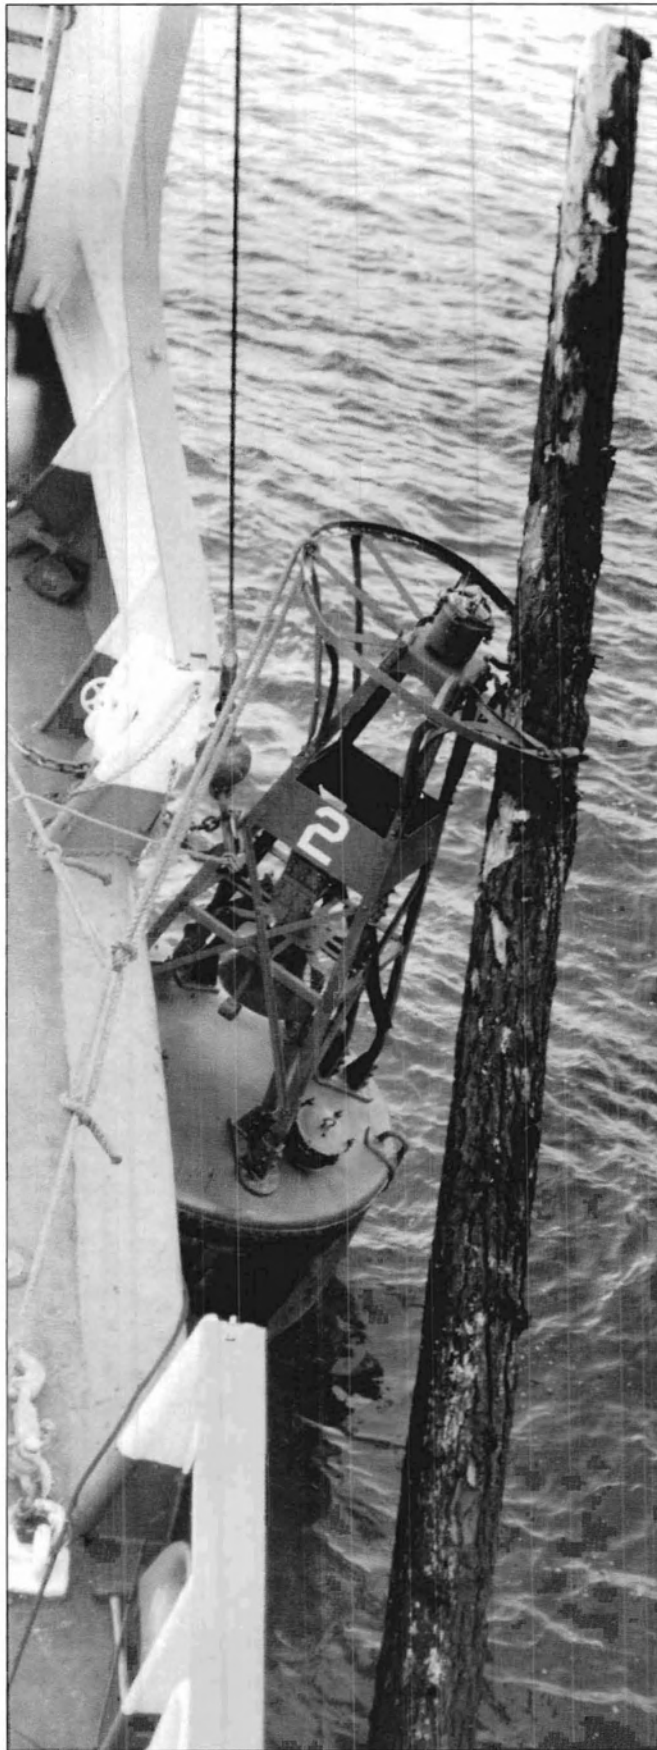
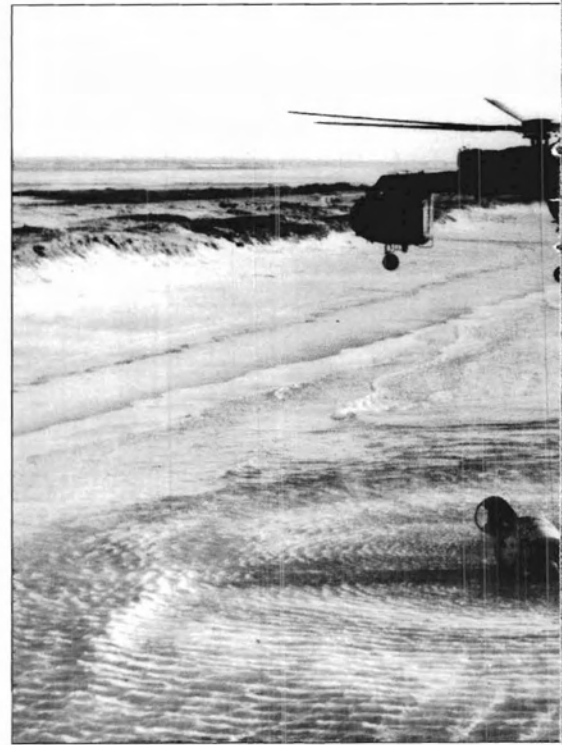
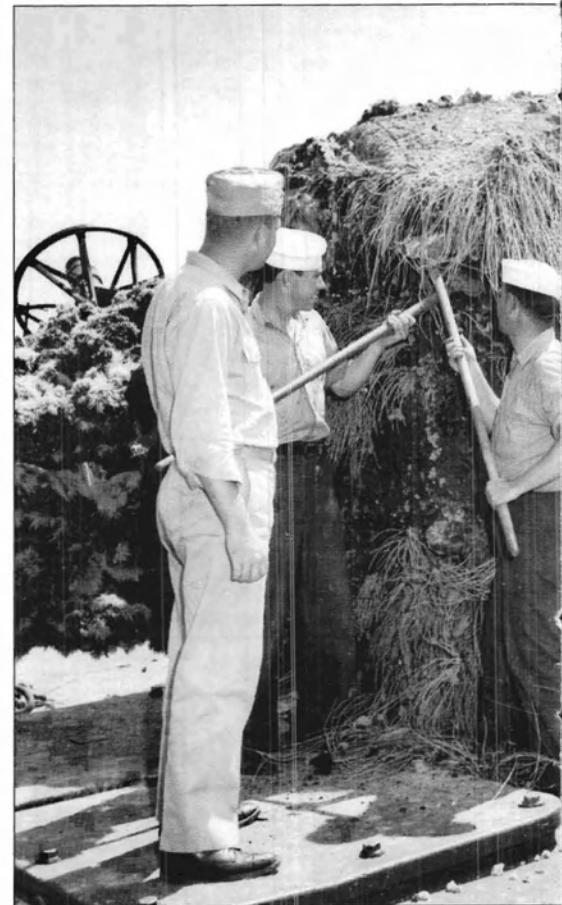
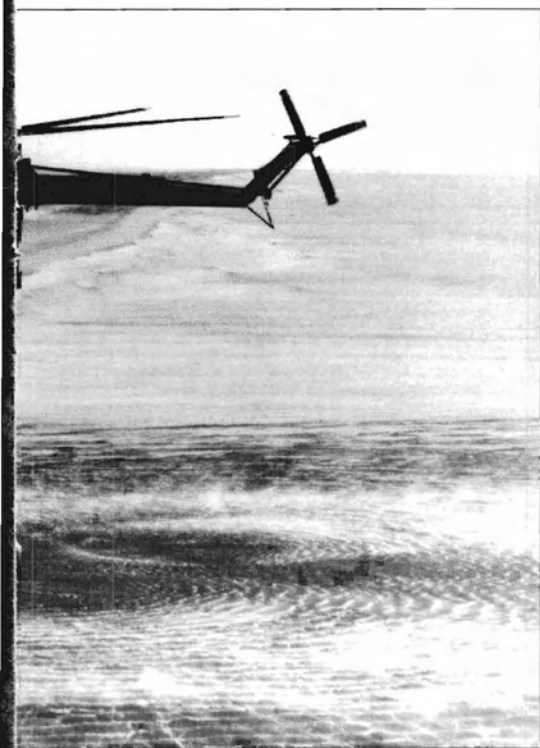
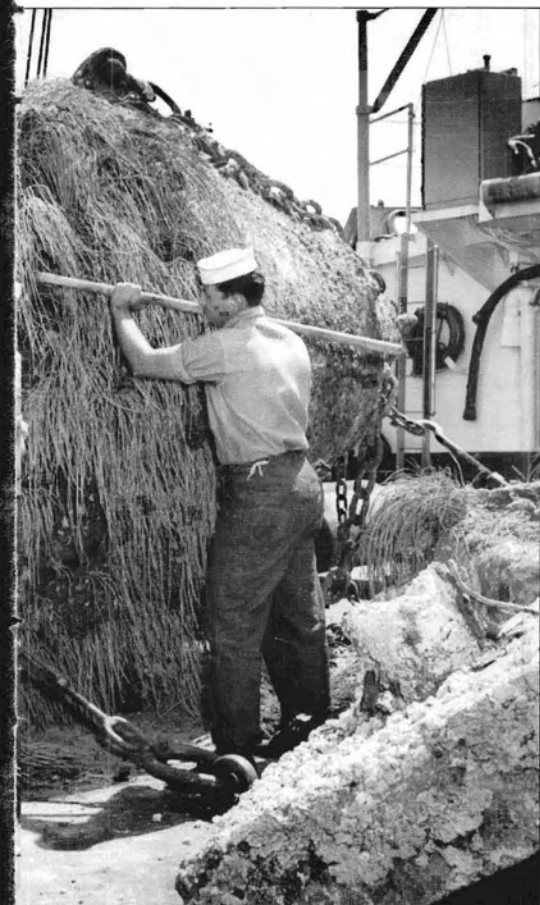
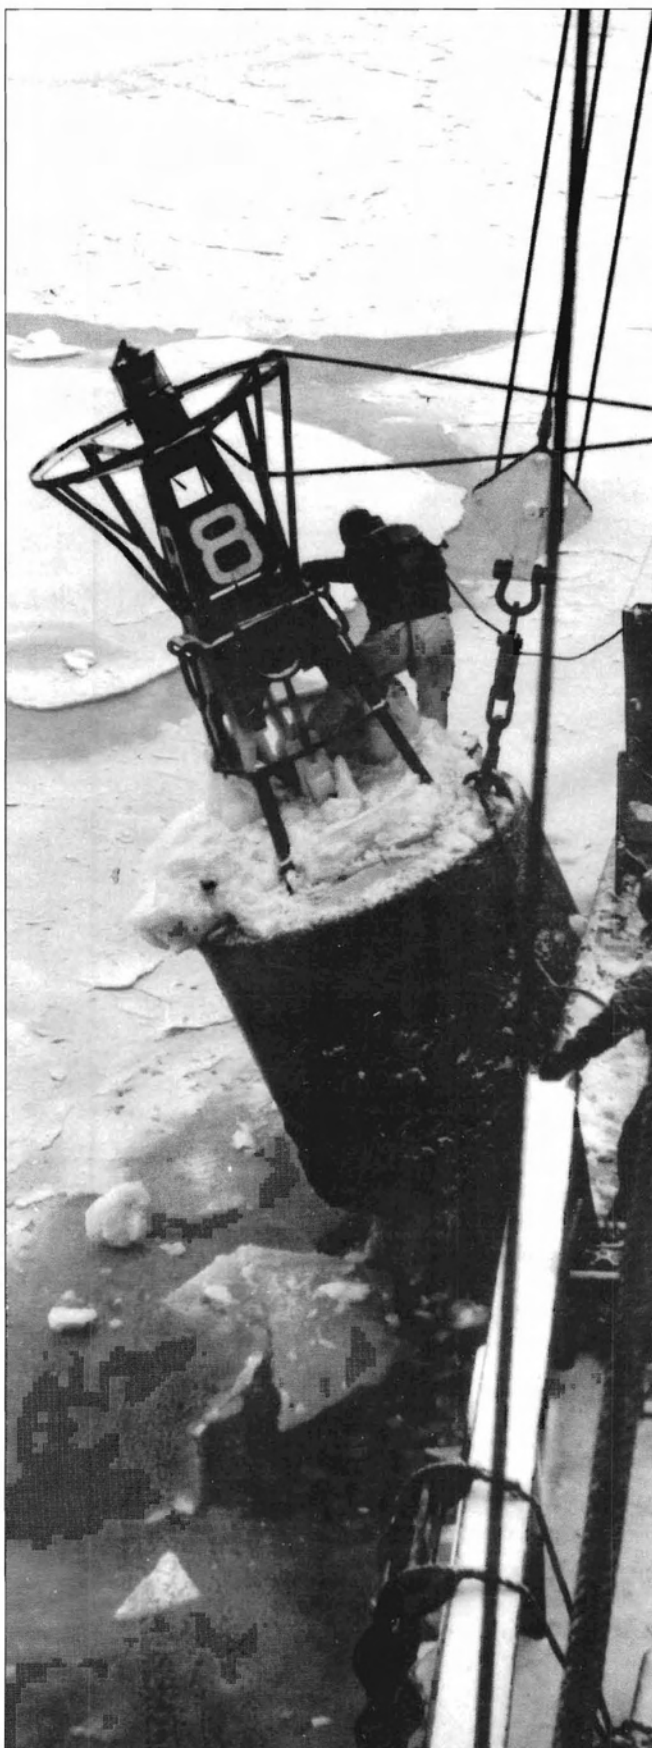
Broken moorings, snags, ice, collisions, marine growth — being a buoy is not all bobbing in the swells. A chance encounter with a snag (far left) left this light-bell buoy lanternless and with a twisted cage. A Chinook helicopter (top center) gives a lift to a buoy that had broken its moorings and washed up on a beach in a marine sanctuary. Foul work removing marine growth from a fouled buoy (bottom center). A ship in the James River (Virginia) struck this buoy and sank it. A Coast Guard tender recovered it six months later. (Left) As ice can jeopardize the stability of ships, it can also capsize and sink buoys. Here, the crew of a tender works to haul in and clean an ice-covered buoy.

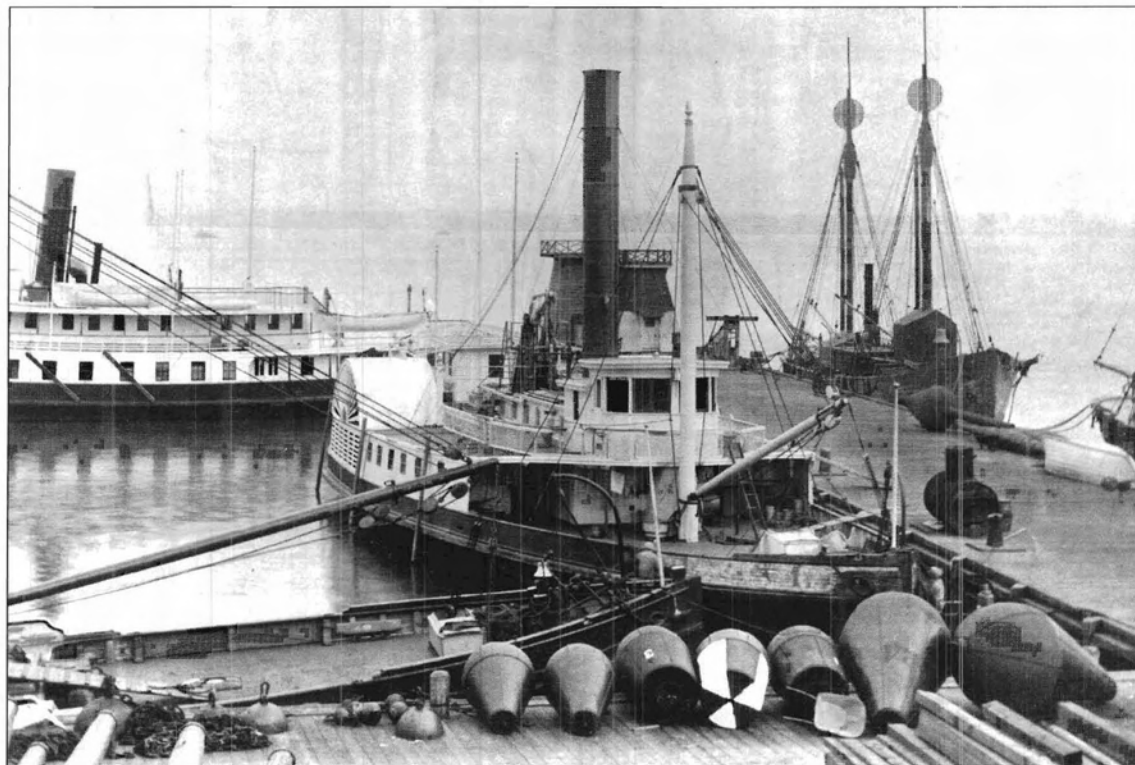
Because emergencies were always a possibility, the Lighthouse Service required district inspectors to keep extra buoys ready. Depots such as this one were common in every district. Pictured here are tenders, a lightship, nun, can, central-channel (white striped) buoys, as well as spar buoys (lower left), mooring chain, sinkers, and ballast balls. On the dock to the right beside the lightship are a Courtenay's whistle buoy and two riveted iron spar buoys.

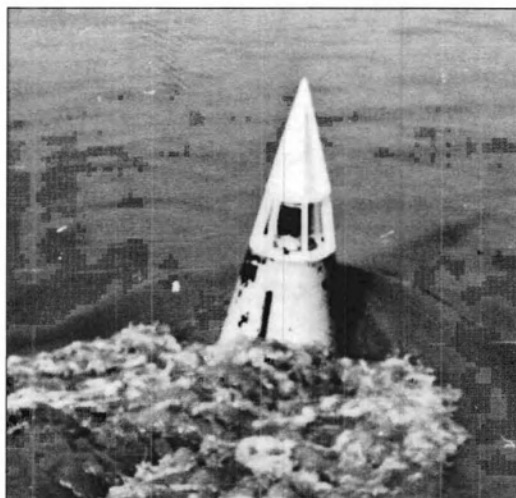
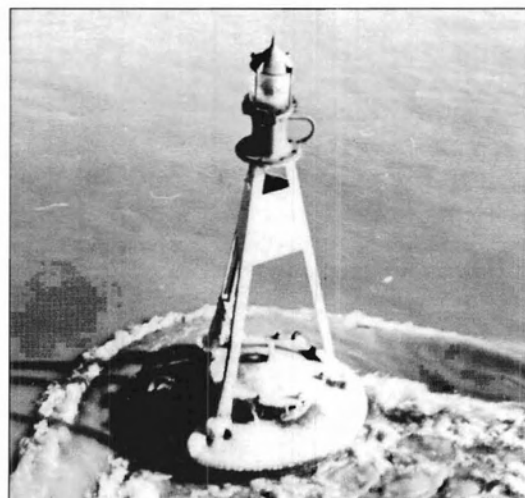
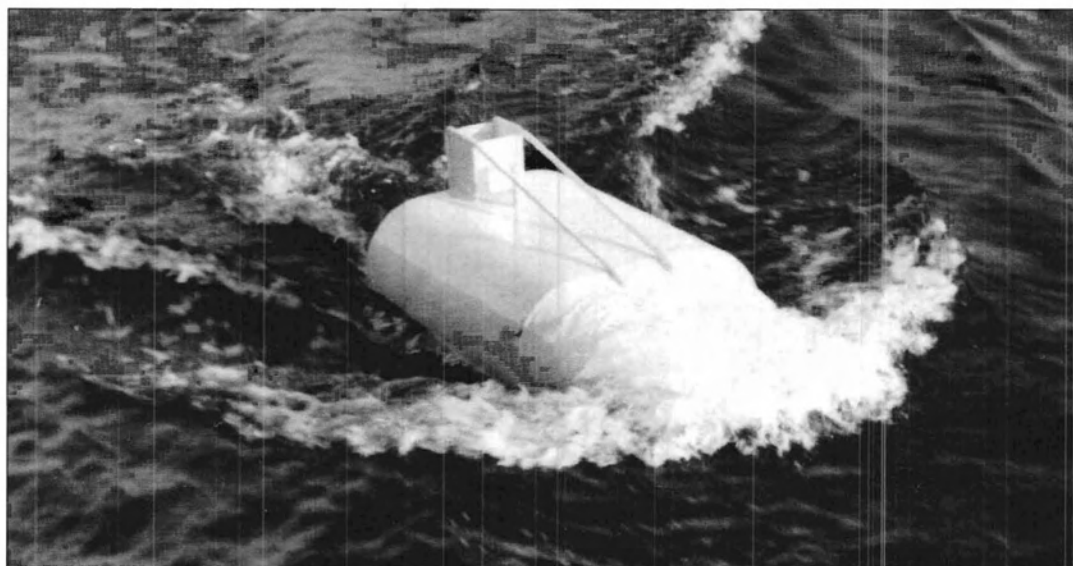
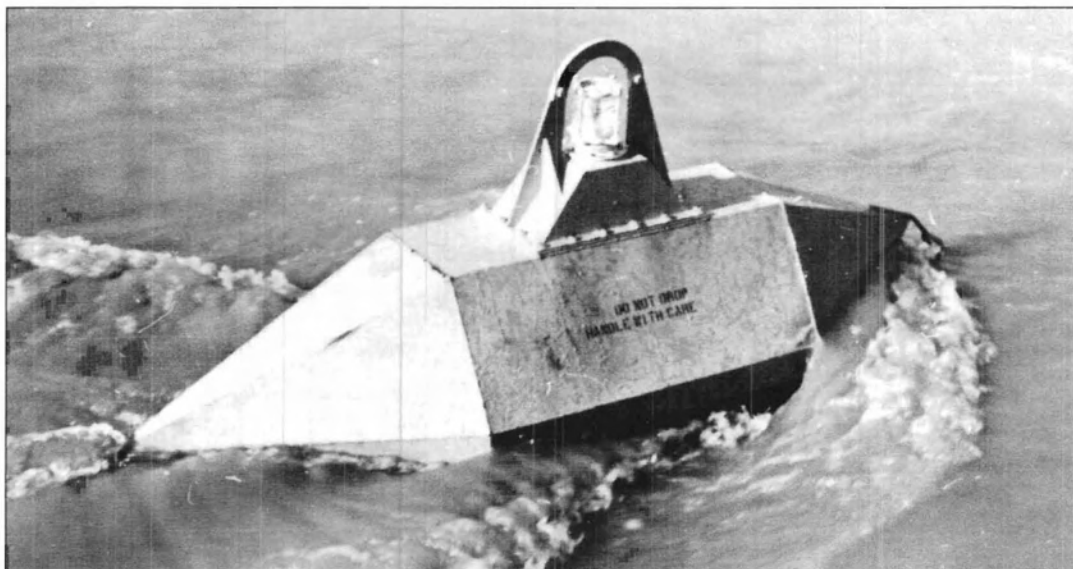
The Coast Guard continued the Lighthouse Service's tradition of experimenting with new buoy designs. In the 1940s and '50s, companies like Wallace and Tiernan and American Gas Accumulator provided prototype buoys for testing in swift-current environments. Four of these test buoys are pictured at right.

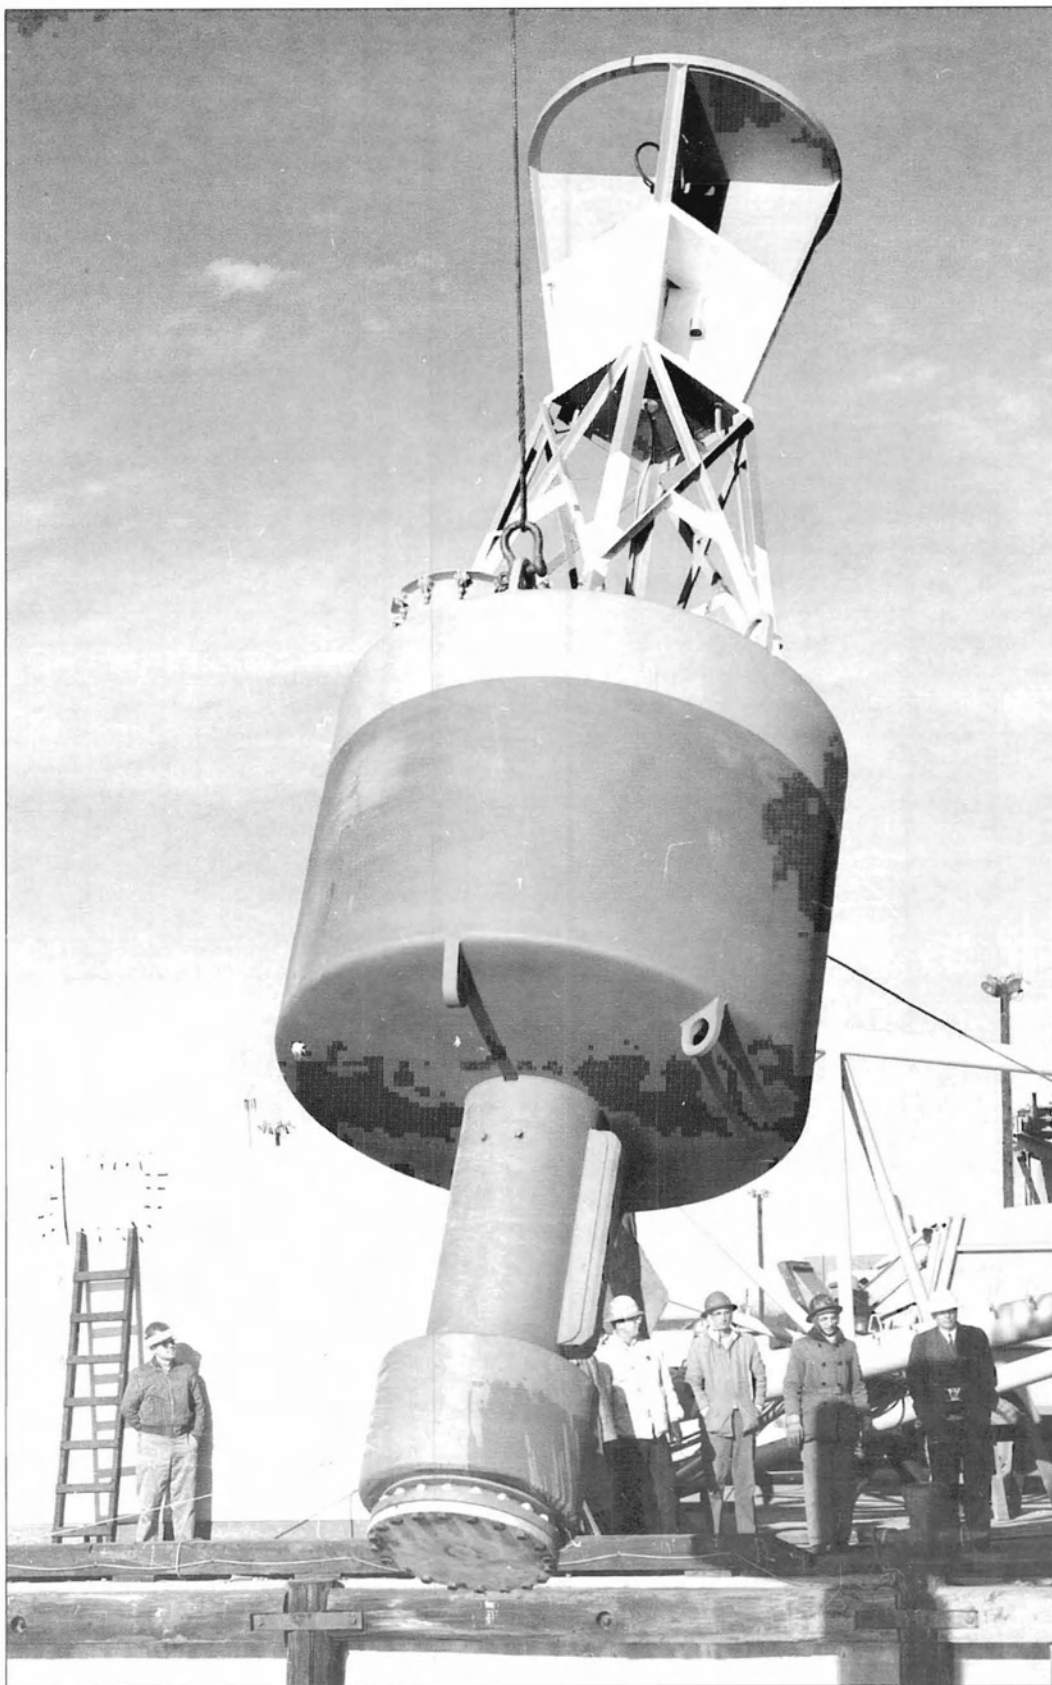
The Atomic Buoy was tested in Baltimore Harbor in 1961. It came complete with a SNAP-7A Strontium 90 generator. The buoy received world-wide attention and was presented as a model for the peaceful use of nuclear power. The generator, however, failed to keep the buoy lit. It was never deployed to its permanent station.

The Coast Guard embraced the promise of atomic power with the induction of its "Ensign Peaceful Atom." This buoy, and its cartoon personification, was touted by the media and the Coast Guard as the new wave in powering navigational aids. It was tested in Baltimore Harbor in 1961 and was quietly removed in 1966 after reports that the nuclear generator failed to keep the buoy lit. Later reports on the atomic buoy experiment admitted that it was a dismal failure.

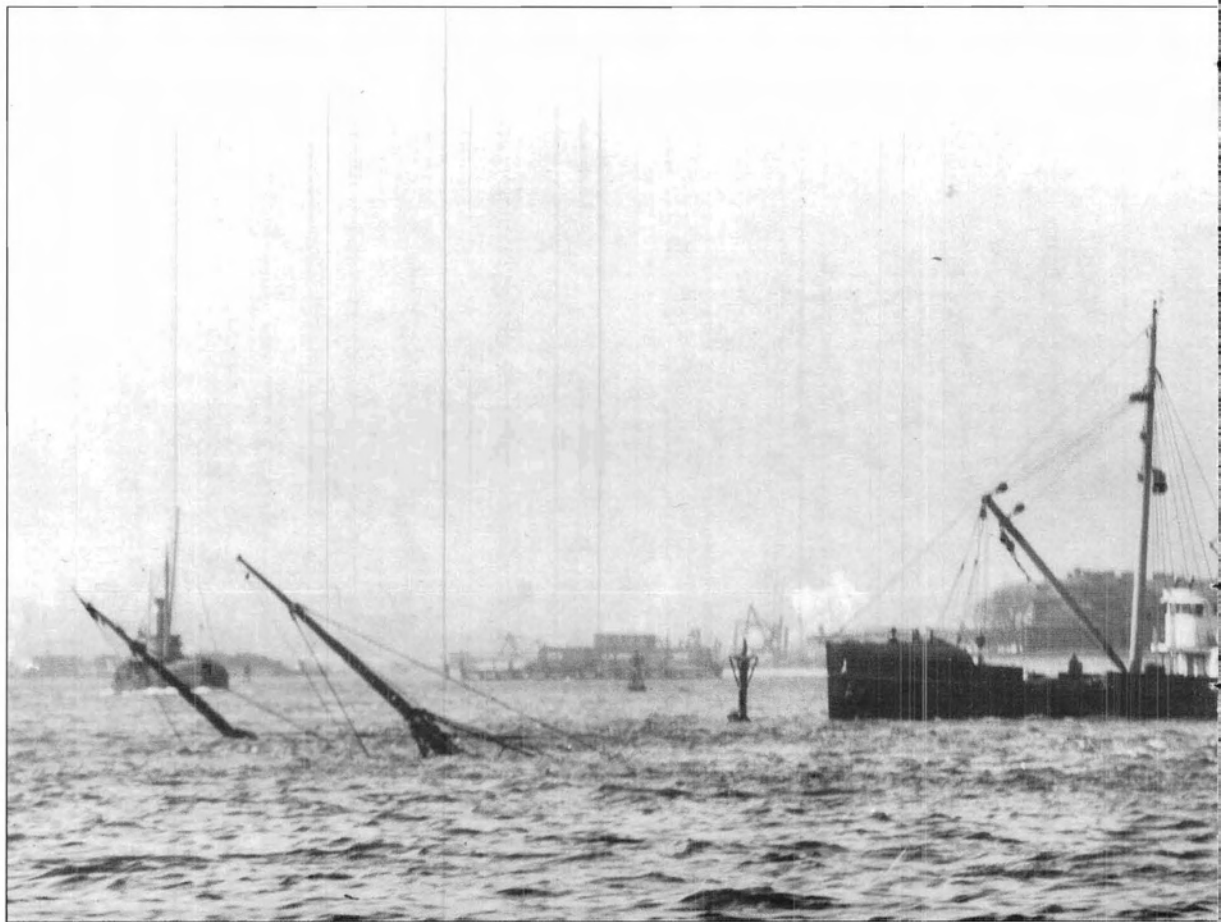
A wreck within sight of the Statue of Liberty, in New York harbor, is visited by a tender with an assortment of buoys. Captains of tenders take responsibility for marking wrecks and other temporary hazards to navigation in addition to their work marking shoals and rocks.
